Assessment of performance of bio self-healing mortar using diatomaceous earth and silica fume

**ASSESSMENT OF PERFORMANCE OF BIO SELF-HEALING MORTAR USING
DIATOMACEOUS EARTH AND SILICA FUME**

Master of Science in Construction Engineering

May 2016

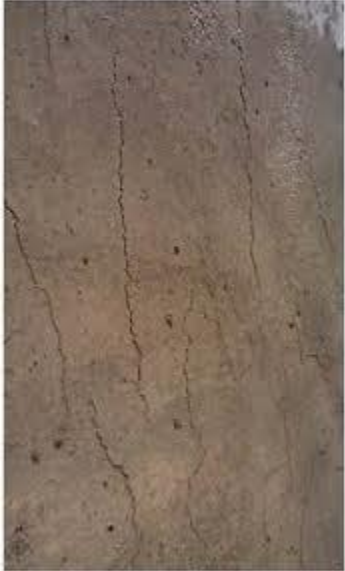
Crack cause	Reason	Picture
Plastic shrinkage	<p>Rapid loss of water while concrete is in the plastic form before it hardens. Such incident creates internal tensile stresses in the weak stiffening plastic concrete which results in shallow cracking.</p> <p>The crack width in this case is a hair line and it can extend through the thickness of concrete (Shen et al. 2016).</p>

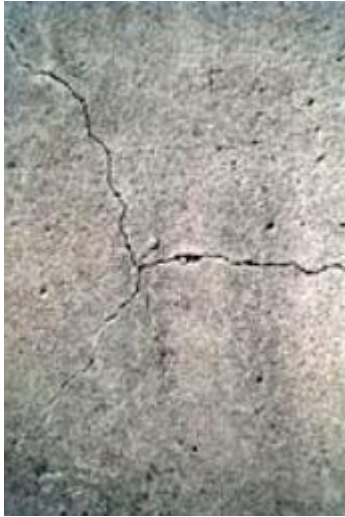
<p>(NRMCA 2014)</p>
Dry shrinkage	<p>Concrete is mixed with excessive water to hydrate the cement, Thus water evaporates after concrete is dried which causes concrete to shrink and accordingly create internal tensile stresses that develops cracks (Shen et al. 2016).</p>

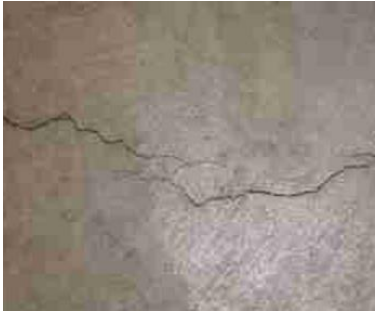
Long-term shrinkage	<p>Shrinkage is a cement paste property that alone, it would shrink up to about 1%; on the other hand, aggregates provide resistant to shrinkage and reduces the shrinkage percent to about 0.06%. Concrete keeps shrinking over its life time though on a lower scale. However, since resistance exists in reinforced concrete, shrinkage causes cracks due to the internal tensile stresses that develop due to differential shrinkage in concrete between interior and surface concrete leading cracks to take place at the thicker section of concrete (Shen et al. 2016).</p>

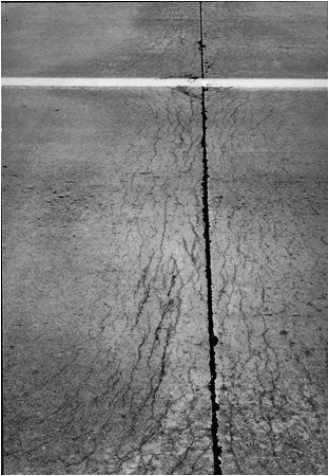
Freeze-thaw cycling	<p>As water increases in volume by 9% when freezes; accordingly, it produces pressure at the concrete and if exceeded the tensile strength of concrete, rupture will occur. The repetition of the freeze and thaw cycles will accumulate disruption of the cement paste that leads to expanding the cracks and compromising concrete integrity (Neville 2011, Mehta 1993).</p>

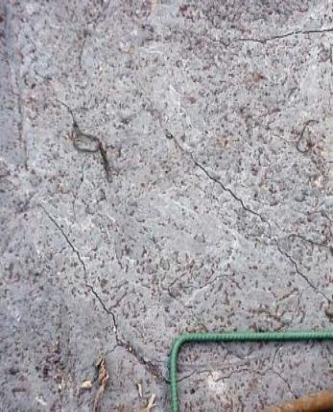
<p>(NRMCA 2014)</p>
Temperature	<p>Temperature variations compiles concrete to expand and contract the length change for concrete (which could vary depending on the type of concrete) is of 5mm for 10m of concrete and, in case of retrain existence to such movement, cracks take place in the concrete mass (Somerville, 2008).</p>

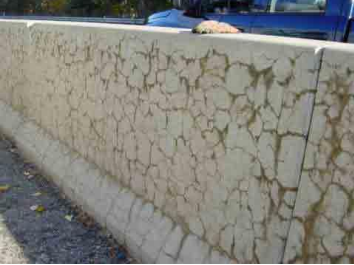
<p>(PEEM 2008)</p>
Chemical reactions	<ul style="list-style-type: none"> • Alkali-aggregate reaction • Sulfate attack • Steel Corrosion (Mehta and Monteiro 1993).

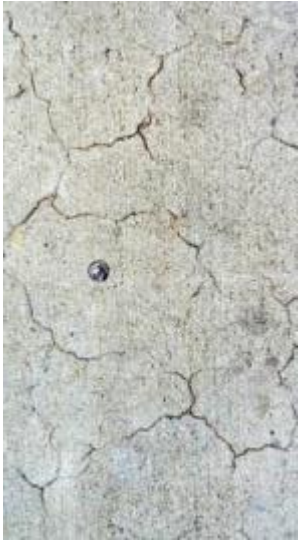
Concrete crazing	<p>When the top surface of concrete losses water rapidly. They form a web of cracks that are extremely fine and usually not repaired (Suyun and Oh 2013).</p>

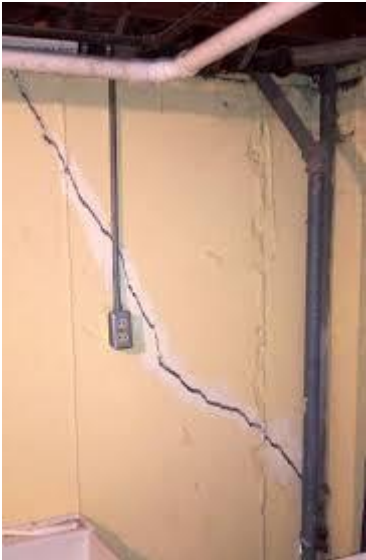
<p>(Gromicko and Shepard 2006)</p>
Errors in design and detailing	<ul style="list-style-type: none"> • The existence of resistant members to concrete masses that are subjected to dimensional instability due to changes in volume by temperature as an example. • Insufficient contraction joints. • Substructure deferential movement that results in initiating cracks especially at window and door openings (Somerville, 2008).

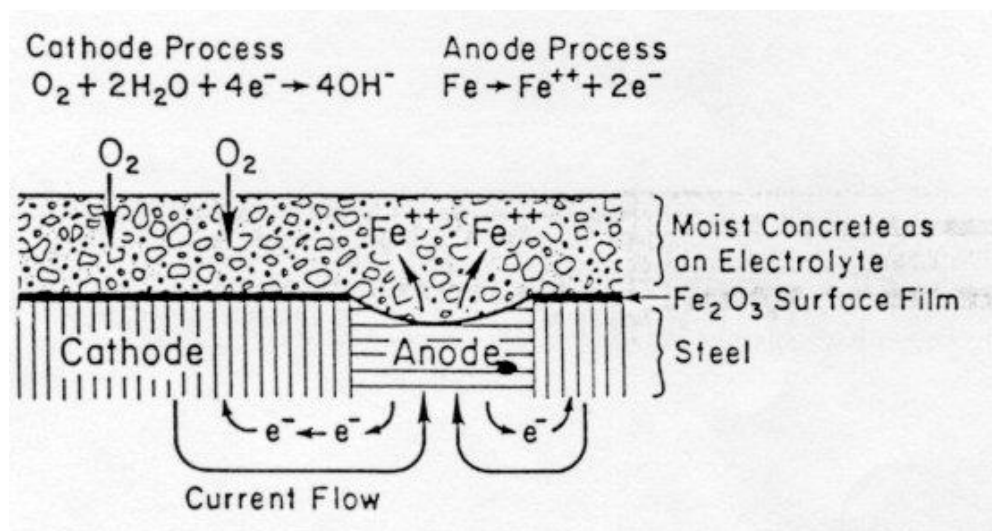
Figure 1-1: Steel Corrosion Process (Mehta and Monteiro 1993)

The fact that concrete has a high pH, contributes as a good environment for steel corrosion (Neville 2011, Reinhardt 1985). When chloride ions enter concrete and reach steel, usually due to cracks, and reach concentration levels of 0.6 to 0.9 kg/m³, it will react with Fe(OH)₂ that

has been formally oxidized due to the specific high pH environment of concrete and forms a water solution and destroy the protective surface of steel (Michel et al 2016). After this stage, steel starts to corrode via an electromechanically process as clarified in the below figure in accordance to the following equations and figure 1-1 the corrosion process (Mehta and Monteiro 1993):

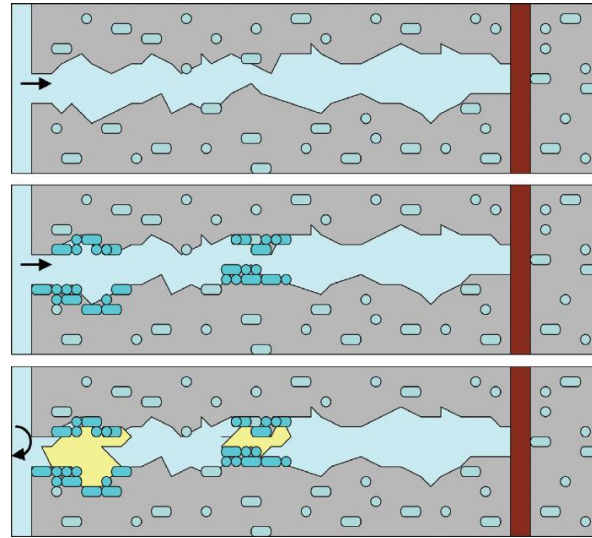
Figure 2-1: Scenario of Self-Healing by Bacteria (Jonkers, 2011)

cracks. Thus for effective self-healing, both bacteria and a bio-binder precursor compound should be integrated in the concrete mixture without negatively affecting other required concrete qualities (Jonkers, 2011).

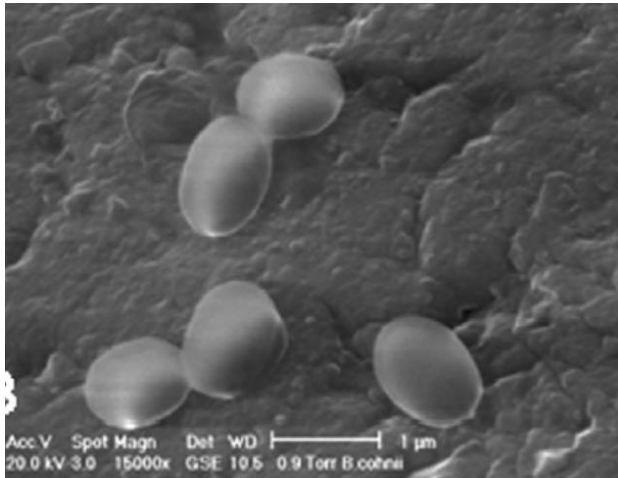
Figure 2-3: SEM Picture showing Bacterial spores in concrete matrix (Jonker, 2009)

precipitated calcite. SEM pictures of Dick et al. (2006) shows a dense and homogeneous layer of calcite produced by *B. sphaericus* strain. In RamKrishnan et al. (1999) study, a *B. Pasteur ii* is shown spread around calcite crystals. In the study done by Wang et al. (2012), SEM pictures acquired shows bacteria immobilized by DE as shown in figure 2-3.

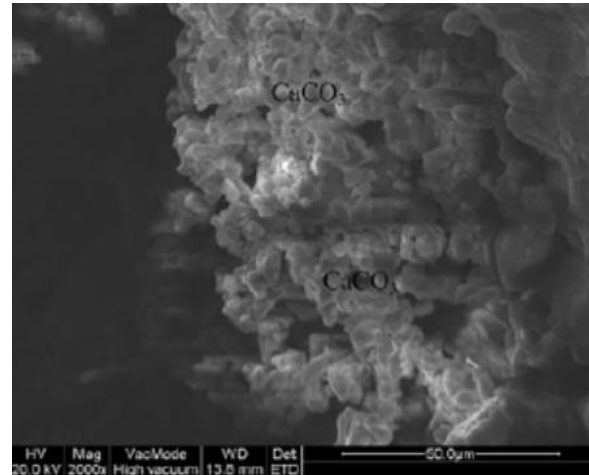
Figure 2-2: SEM Picture showing bacteria immobilized by DE (Wang. J. Y, 2012)

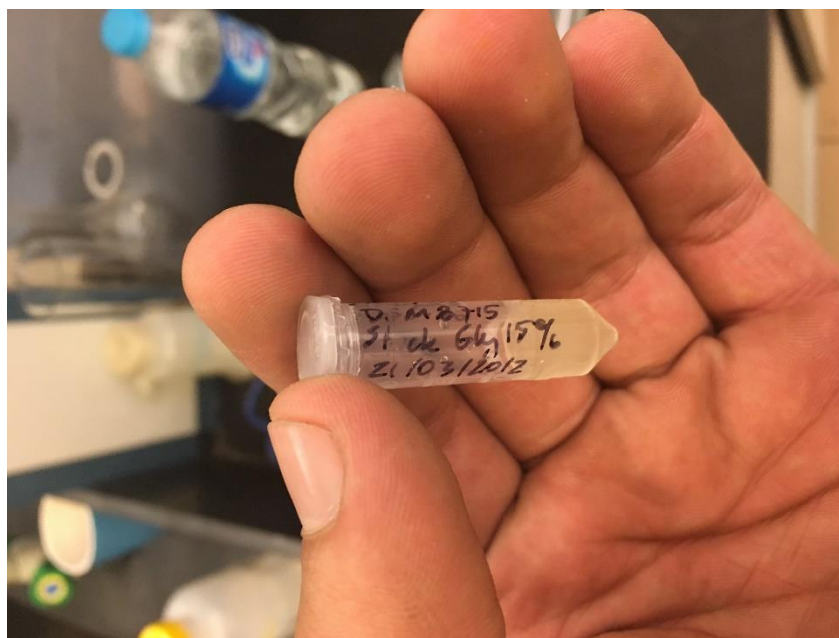
Figure 3-1: Bacteria Strains in Stock Form

Bacillus Pseudofirmus DSM 8715 strains were purchased from the DSMZ (German Collection of Microorganisms and Cell Cultures), Braunschweig, Germany isolated from lake bank soil in Germany. Table 3-1 lists present bacteria data and Figure 3-1 shows bacteria strains in their stock form.

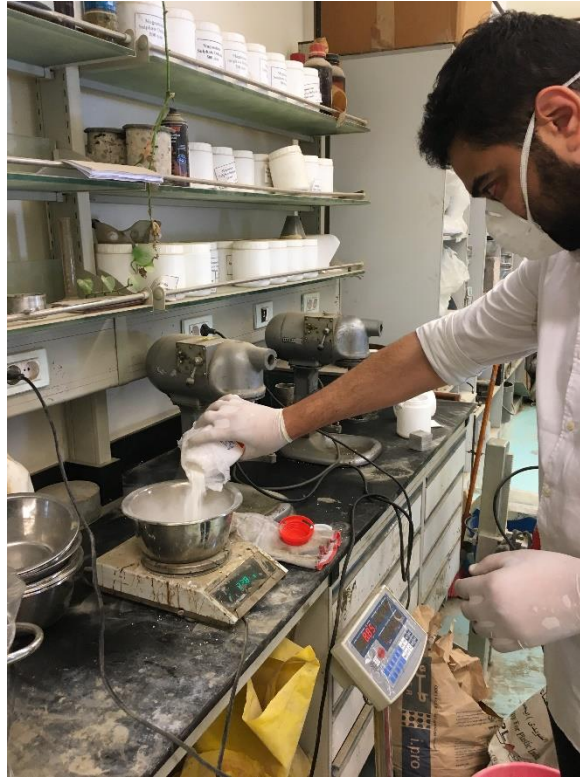
Figure 3-2: Calcium Lactate

Calcium lactate salt ($C_6H_{10}CaO_6$) is used in its powder form with a molar mass of 218.22 g/mol and density of 1.494 g/cm^3 as a precursor for bacteria vegetation. Figure 3-1 shows the calcium lactate particles in its powder form balanced.

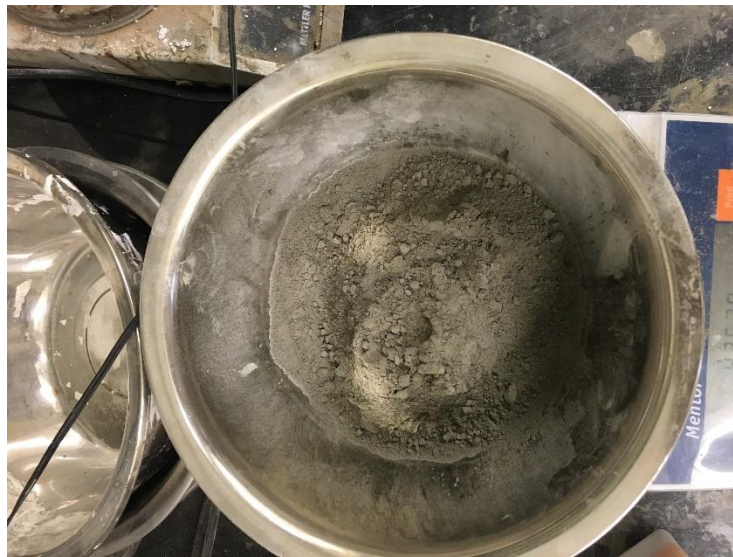
Figure 3-3: Cement

Ordinary Portland cement manufactured by one of the local companies in Egypt has been used with a particle nominal size of $1 \mu\text{m}$ and with the following properties as listed in table 3-4. Figure 3-3 shows cement particles in its powder form.

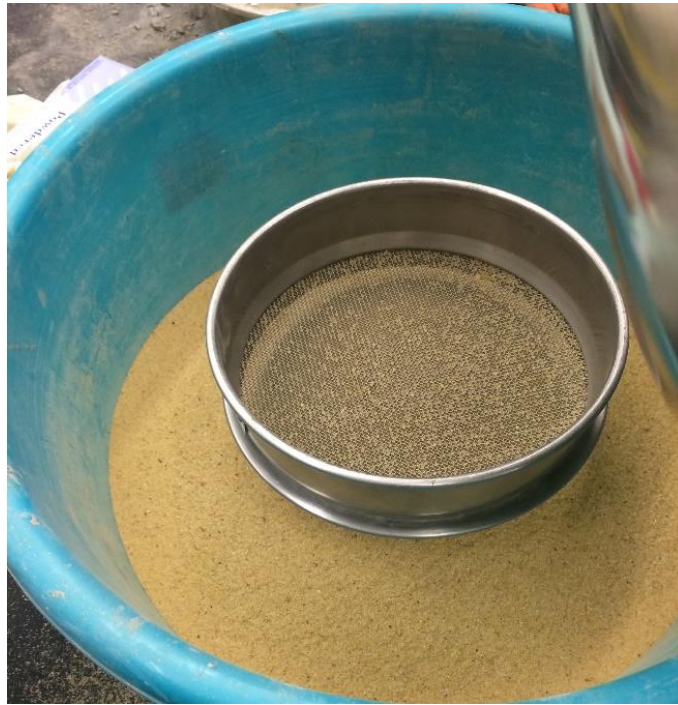
Figure 3-4: Fine Aggregates

The sand used in this study is standard sand passed from sieve# 20 and retained on sieve# 30. This type of sand has been chosen according to ASTM C190 and to minimize variations due to supply of sand throughout the experimental work. This sand attained a fineness modulus of 2.80 and a saturated surface dry specific gravity of 2.60. The absorption of fine aggregate was experimentally measured at 0.73%. Figure 3-4 shows fine aggregates used.

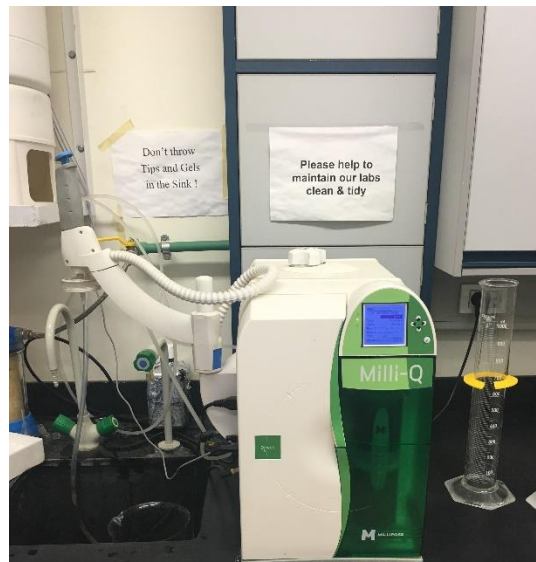
Figure 3-5: Mili-Q device used for generating purified water

Mili-Q water that is ultra-purified and ionized water has been used for bacteria preparation and tap water was used for both mixing and curing. Figure 3-5 shows the device used for generating purified water used.

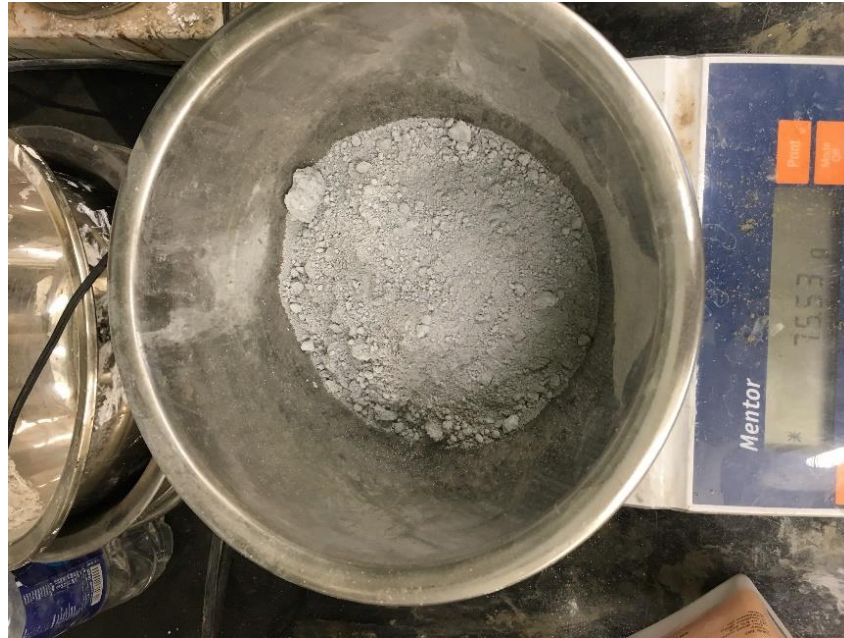
Figure 3-6: Silica Fume

The silica fume used in this study was brought from a local manufacturer. This type of silica-fume has grain size $0.15\ \mu\text{m}$, bulk density $0.5\ \text{kg/l}$ and specific surface $20\ \text{m}^2/\text{g}$. It contains extremely fine ($0.15\ \mu\text{m}$) latently reactive silicon dioxide (minimum of 90%). Figure 3-6 shows the silica fume used.

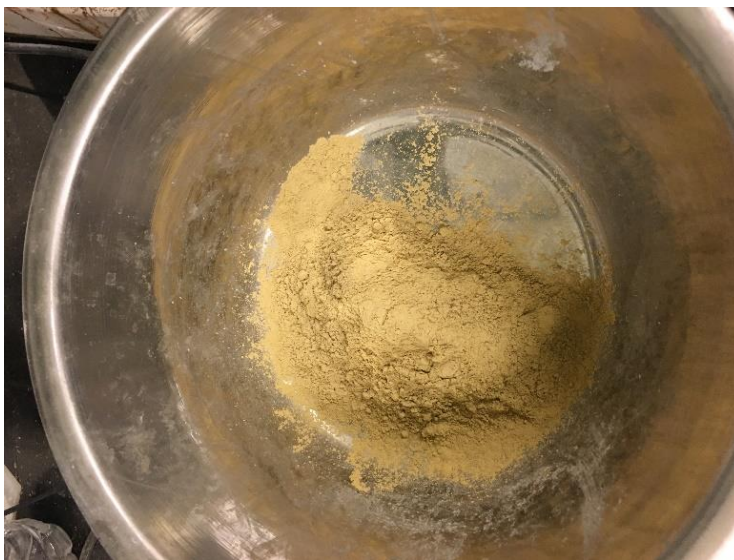
Figure 3-7: Bentonite

Bentonite has been purchased from a local supplier in Egypt and was acquired from the New Wadi Governorate in Egypt passing sieve #200 and with a free swell of 60% by volume and having a Pozzolanic nature. Figure 3-7 shows the used Bentonite in this study. Bentonite used was burned in the oven on a temperature of 400°C in order to force it to lose its water retention property and can form an immobilization protection for bacteria and storage for calcium lactate after its volume increased.

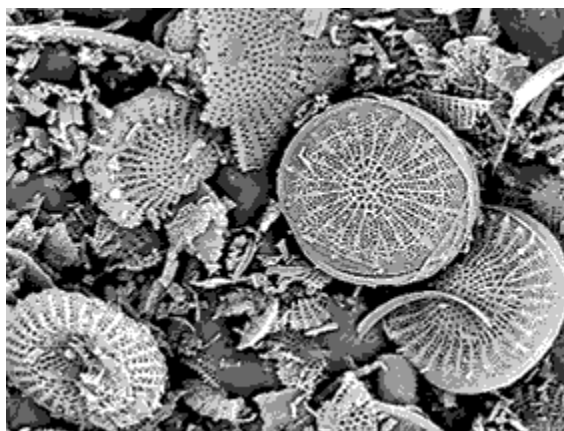
**Figure 3-8: Diatomaceous earth (DE)
under SEM**

Diatomaceous Earth (DE) which is a porous sedimentary fossils of diatoms with a particle size ranging from $1\mu\text{m}$ to 1 mm . (DE) is chemically inactive. DE for this study was acquired from company Dicalite Europe NV, Belgium. Figure 3-8 shows the DE with the use of SEM.

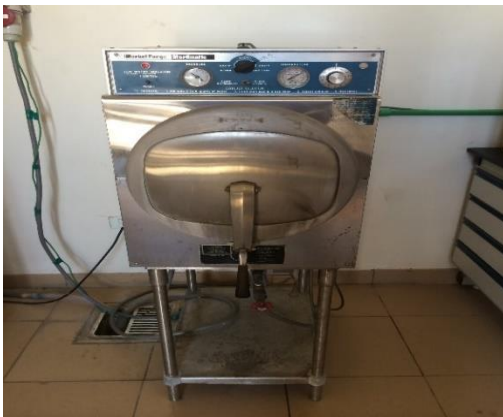
Figure 3-9: Autoclave device

After the bacteria stock was imported from Germany, it was put in a -80°C fridge in order to reserve it for further use. Culture media was prepared by adding 8g of nutrient Broth to a 0.9 liter of ionized water generated from a Mili-Q water filter. The container containing the nutrient broth media and water was sterilized by autoclaving on a 120°C and a pressure of 1.5 bar for 20

minutes. Figure 3-9 shows the Autoclave and Figure 3-10 shows the media container after sterilizing. The media was then cooled to room temperature 25°C.

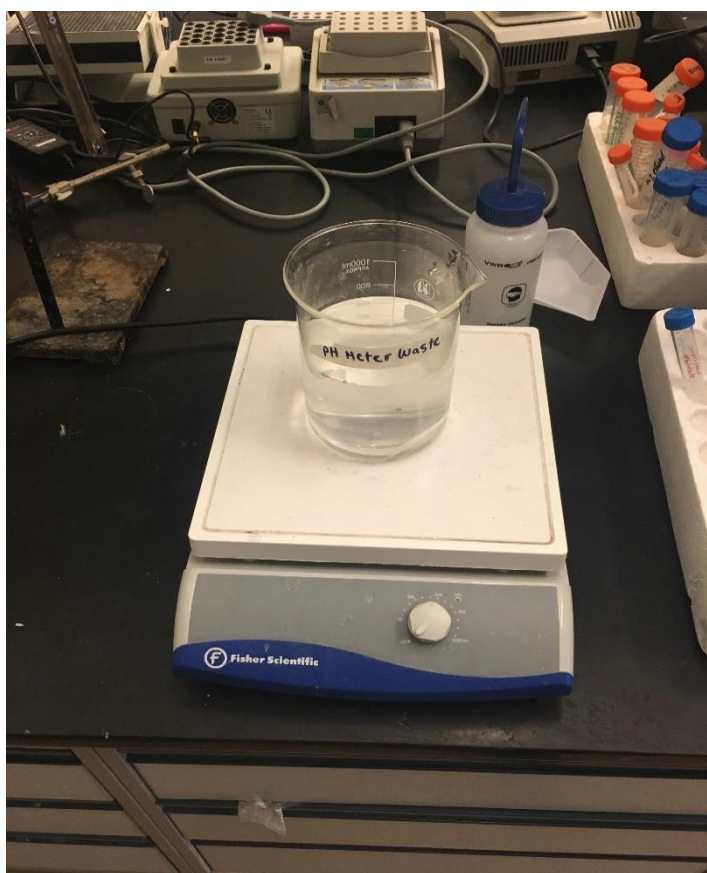
Figure 3-11: Magnetic stirrer equipment

Na-sesquicarbonate solution was prepared by adding 4.2 g NaHCO_3 and 5.3 g Na_2CO_3 to 0.1 liter of ionized Milli-Q water which was dissolved using a magnetic stirrer equipment as shown in figure 3-11 the solution was further filtered using a 0.2 micrometer filter under a laminar flow cabinet as shown in figure 3-12 to insure no bacteria from the surrounding environment interfere in the experimental work.

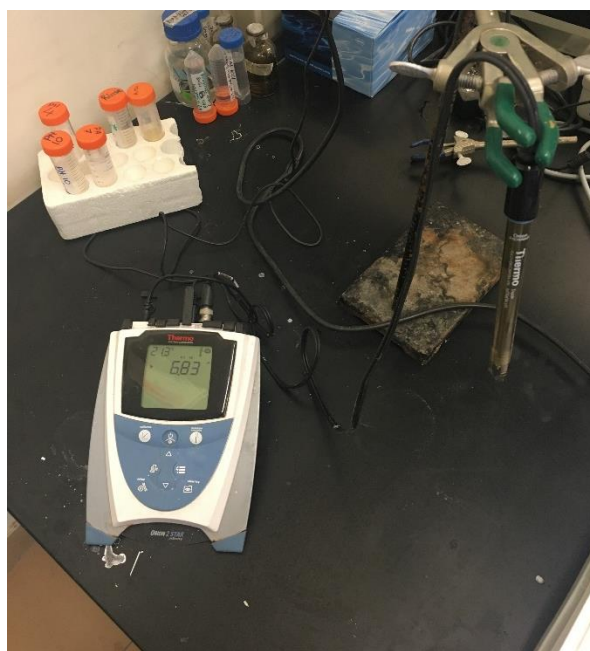
Figure 3-13: pH meter

Na-sesquicarbonate solution that was prepared was added to the culturing media in order to attain a pH level of 9.7 which is the optimum environment for the *Bacillus Pseudofirmus* growth. The pH level was measured using pH meter as shown in figure 3-13.

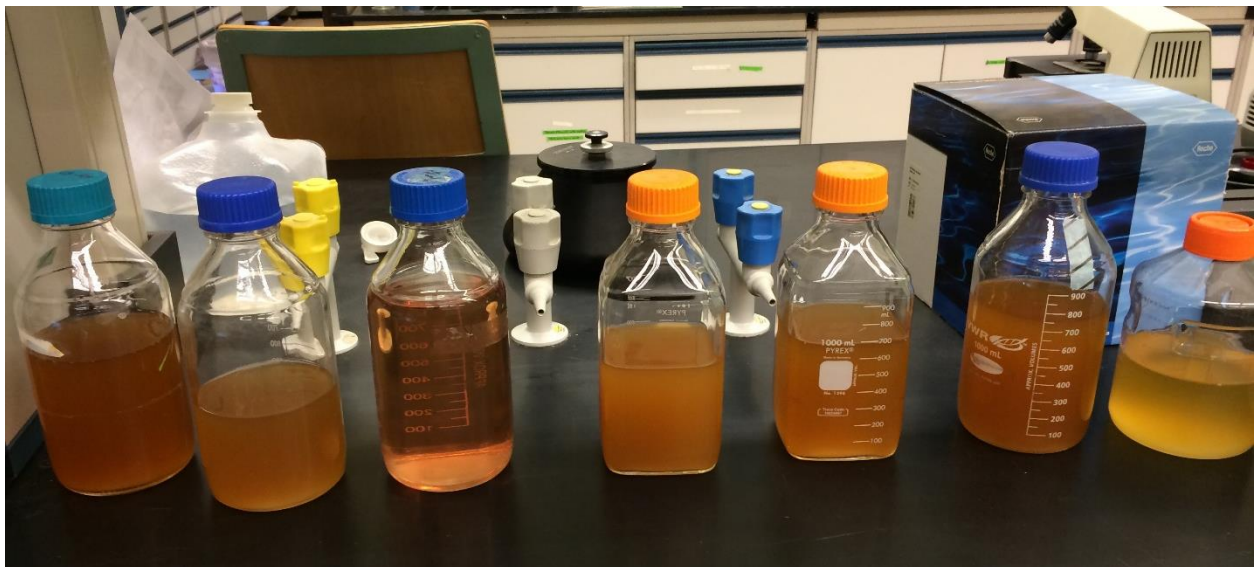
Figure 3-14: Turbid media

The growth was investigated with visual inspection when noticing that the medium turned turbid as shown in figure 3-14. Sample of the media with the bacteria was then taken to investigate the growth rate using Spectrophotometer equipment which was 0.9. Figure 3-15 shows Spectrophotometer equipment used in this study.

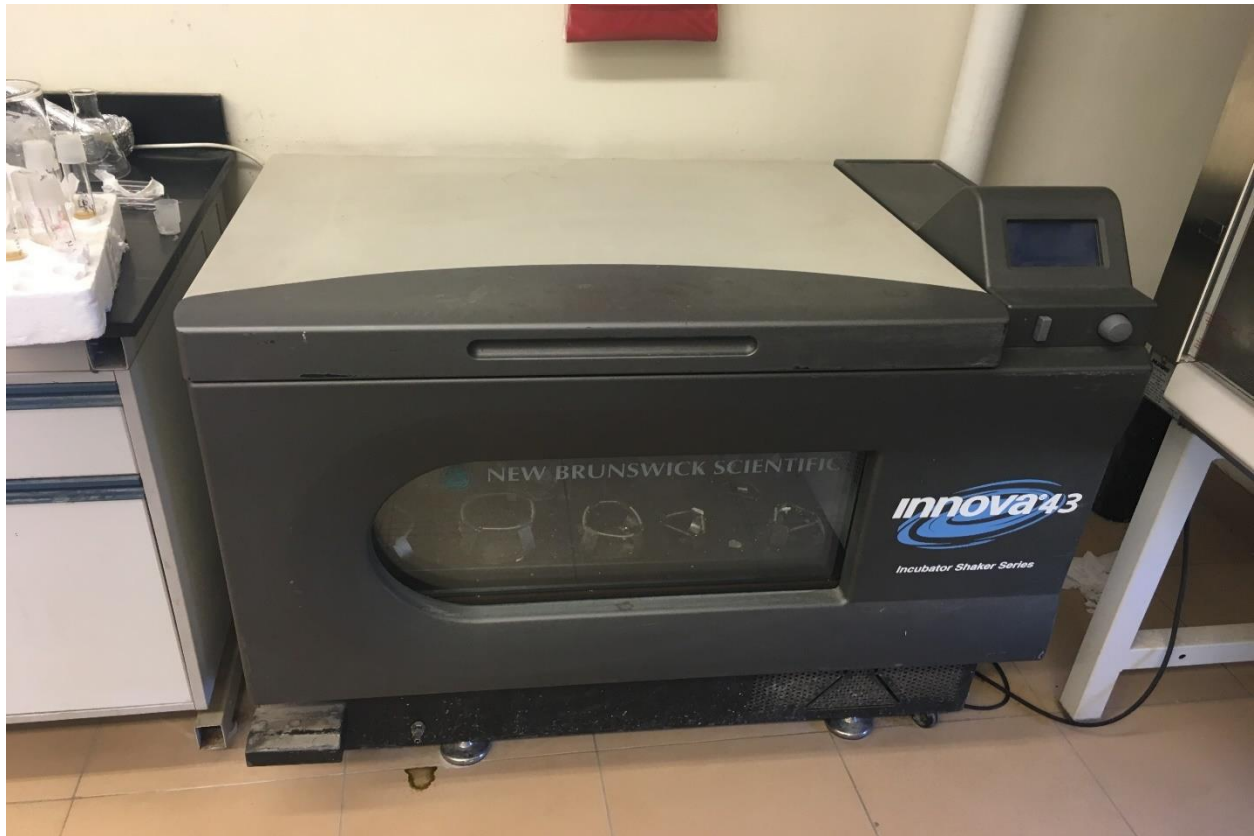
Figure 3-16: Incubator shaker

Containers of one liter capacity was then autoclaved and the 1 liter growth media was then divided on them under the laminar flow cabinet and the falcon tubes containing the bacteria was poured in each of them and were left in an incubator with 30°C and a shaking rate of 150 rpm for 15 hours to initiate bacteria growth in larger amounts. Figure 3-16 shows the incubator shaker used.

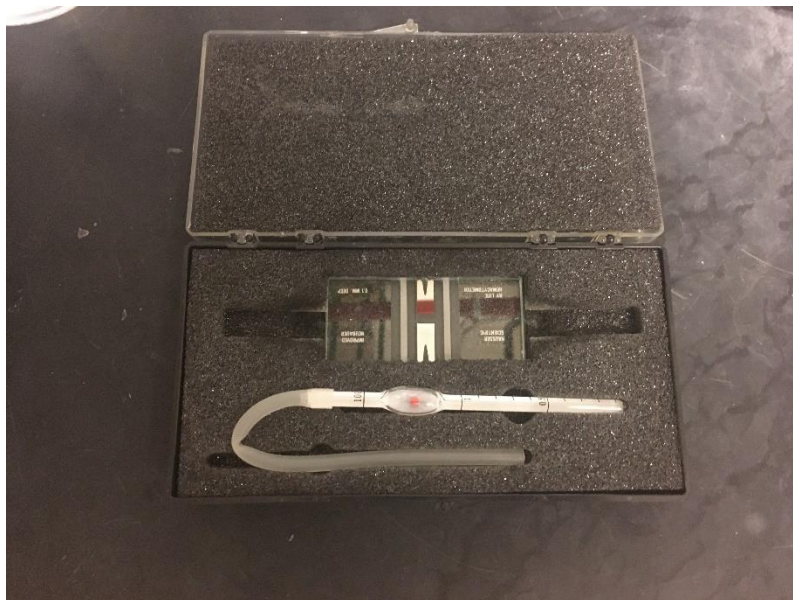
Figure 3-17: Hemocytometer

The above procedure was repeated for ten liters of the culturing media and bacteria was then counted using Hemocytometer equipment shown in figure 3-17.

The viability of spores were tested on plates that contained a media of agar and calcium lactate. Spores of bacteria were counted using Hemocytometer and divided into three dosages of 3×10^8 , 6×10^8 and 10^9 cm^{-3} .

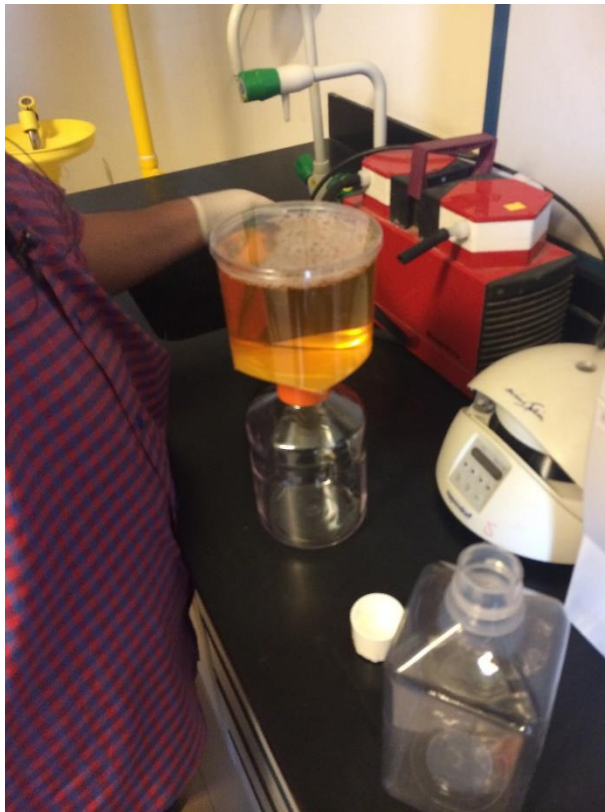
Figure 3-18: Filtration pump

Spore-forming compounds with weights as listed in table 3-3 were balanced and filtered using a filtration pump shown in figure 3-18. Bacteria in the growth media was harvested using a centrifuging equipment shown in figure 3-19 that revolves with a rate of 10,000 rpm for 10 minutes and then the bacteria pellets were suspended in the spore-forming media and left in an incubator with 30°C and a shaking rate of 150 rpm for 15 hours. Samples of the spore forming bacteria were then harvested and put under microscope to ensure sporulation of the bacteria. Figure 3-20 shows harvested bacteria pellets. Spore-forming media that includes bacteria spores was then centrifuged with a rate of 10,000 rpm for 10 minutes and bacteria pellets were suspended in tap water to be ready for use in mortar mix designs.

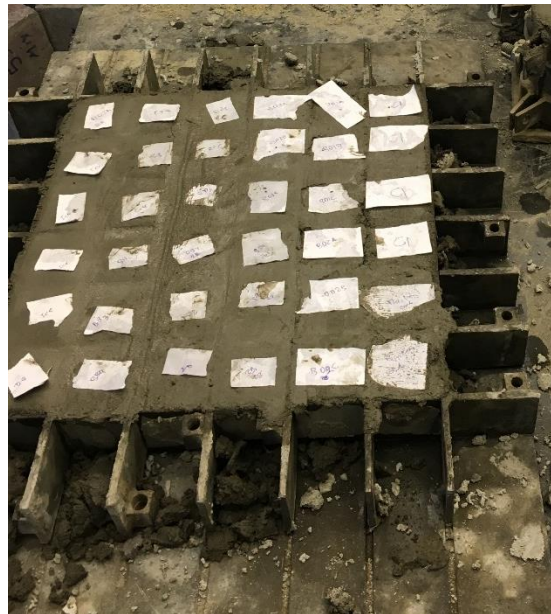
Figure 3-21: Mortar Cubes casted in molds

Standard cubes of size (50x50x50) mm were prepared for the compressive strength to be tested after 7, 14 and 28 days as shown in figure 3-21. Cylindrical specimens were prepared for the indirect tension test with a diameter of 5 cm and a length of 10 cm as shown in figure 3-22. Cylindrical specimens with a diameter of 10 cm and a length of 5 cm were prepared for the rapid chloride permeability test as shown in figure 3-23. And standard cubes of (50x50x50) mm were prepared for chemical soundness test.

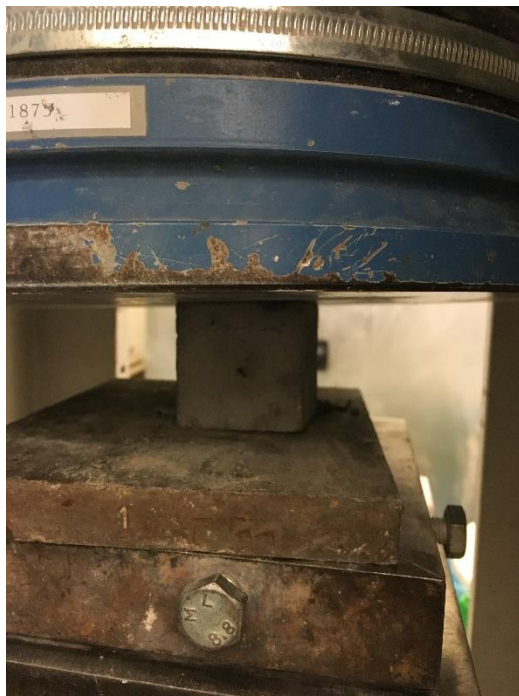
Figure 3-24: Cube Loaded

Compressive test was conducted on the age of 7, 14 and 28 of the healing specimens. Cubes were loaded on a universal testing machine as shown in figure 3-24 and figure3-25 and loaded until failure and results were taken and tabulated.

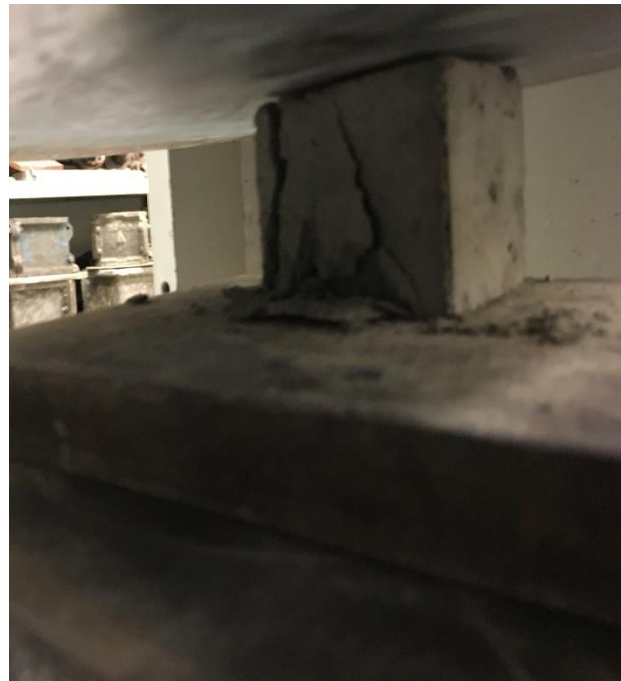
Figure 3-25: Cube fracture after uplying ultimat compressive load

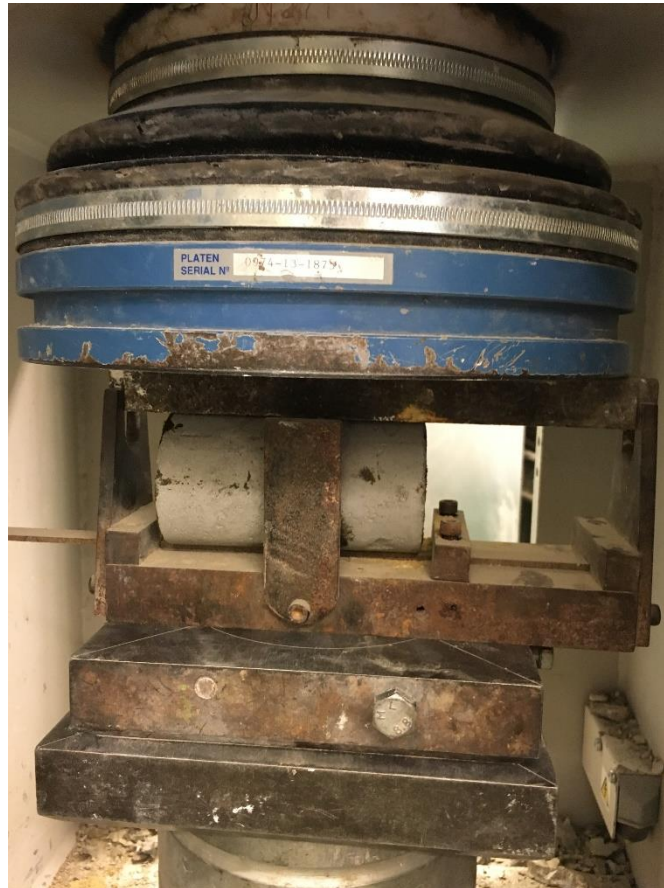
Figure 3-26: Indirect Tension Test

Cylindrical specimens assigned for indirect tension test were taken from the curing room and a universal testing machine shown in figure 3-26 was used to load the specimens after 7 days of curing and again after 28 days of curing and results were tabulated.

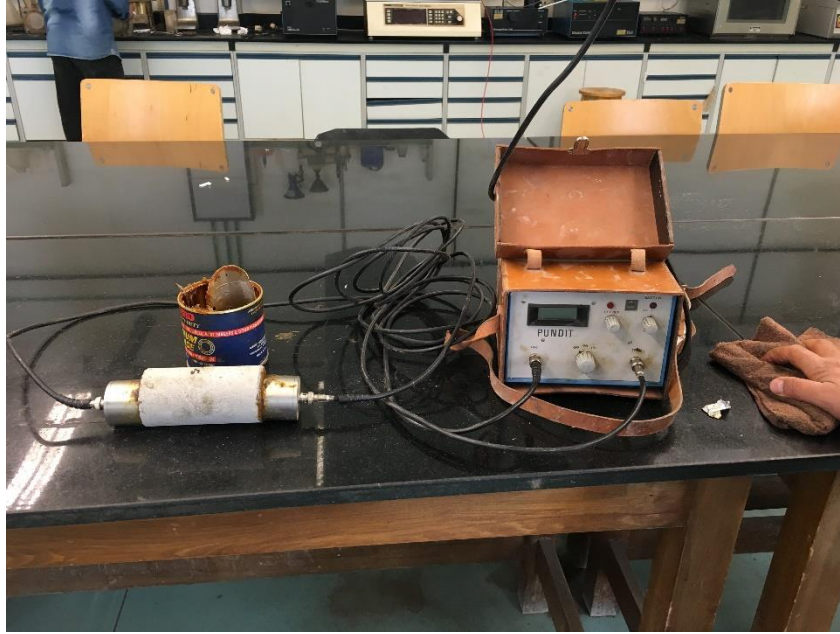
Figure 3-27: Ultrasonic pulse velocity test

Ultrasonic pulse velocity test was performed using the apparatus shown in figure 3-27 at the age of 14 and 28 days on the cracked specimens.

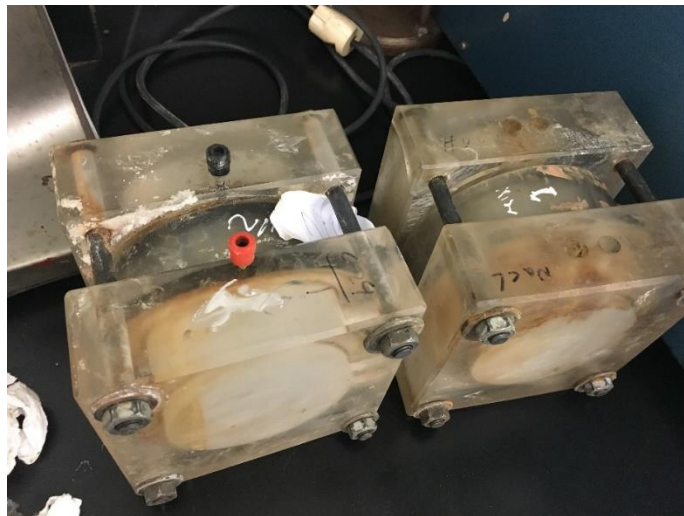
Figure 3-28: Rapid chloride permeability test set up

This test was conducted in accordance with the ASTM C 1202-97. The set up used for this test are shown in figure 3-28.

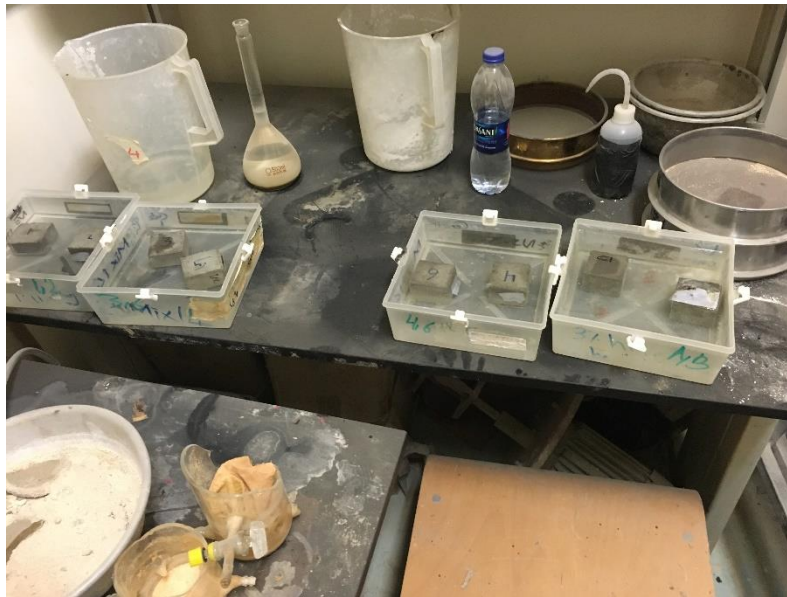
Figure 3-29: Chemical soundness test set up

Chemical soundness test was conducted on the cubical specimens assigned for this test and were submerged in a magnesium sulfate and sulfuric acid compounds. Figure 3-29 shows the test set up.

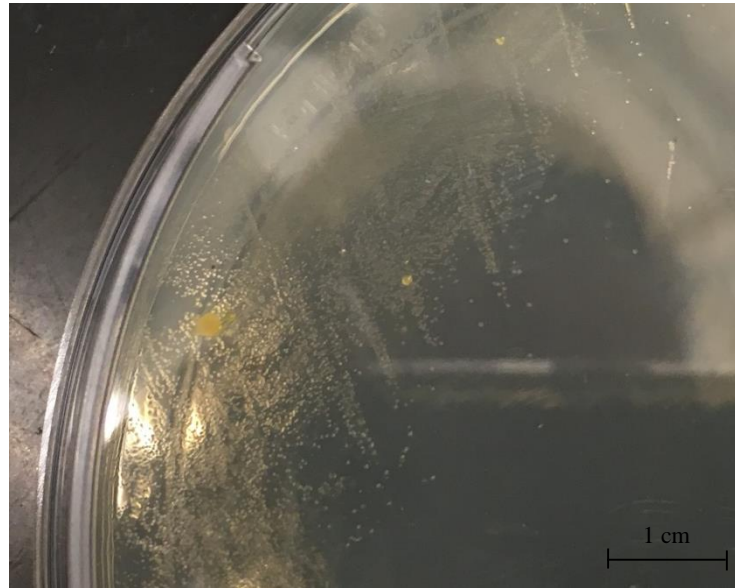
Figure 4-1: Appearance of few colonies after two days

After spores were put on agar plates that contained calcium lactate, the appearance of few colonies started to appear as shown in figure 4-1 after two days which is attributed to the enhancement of growth conditions created to mimic the food-enriched environment that the bacteria would be exhibited to inside the mortar matrix. The growth noticed by eye inspection indicates that spores have actually transformed from its idle phase to a vegetative bacterial phase when the environment was suiting its growth and increased in number.

This test provided us with an indication that the culturing and sporulation processes that we have worked in were successful.

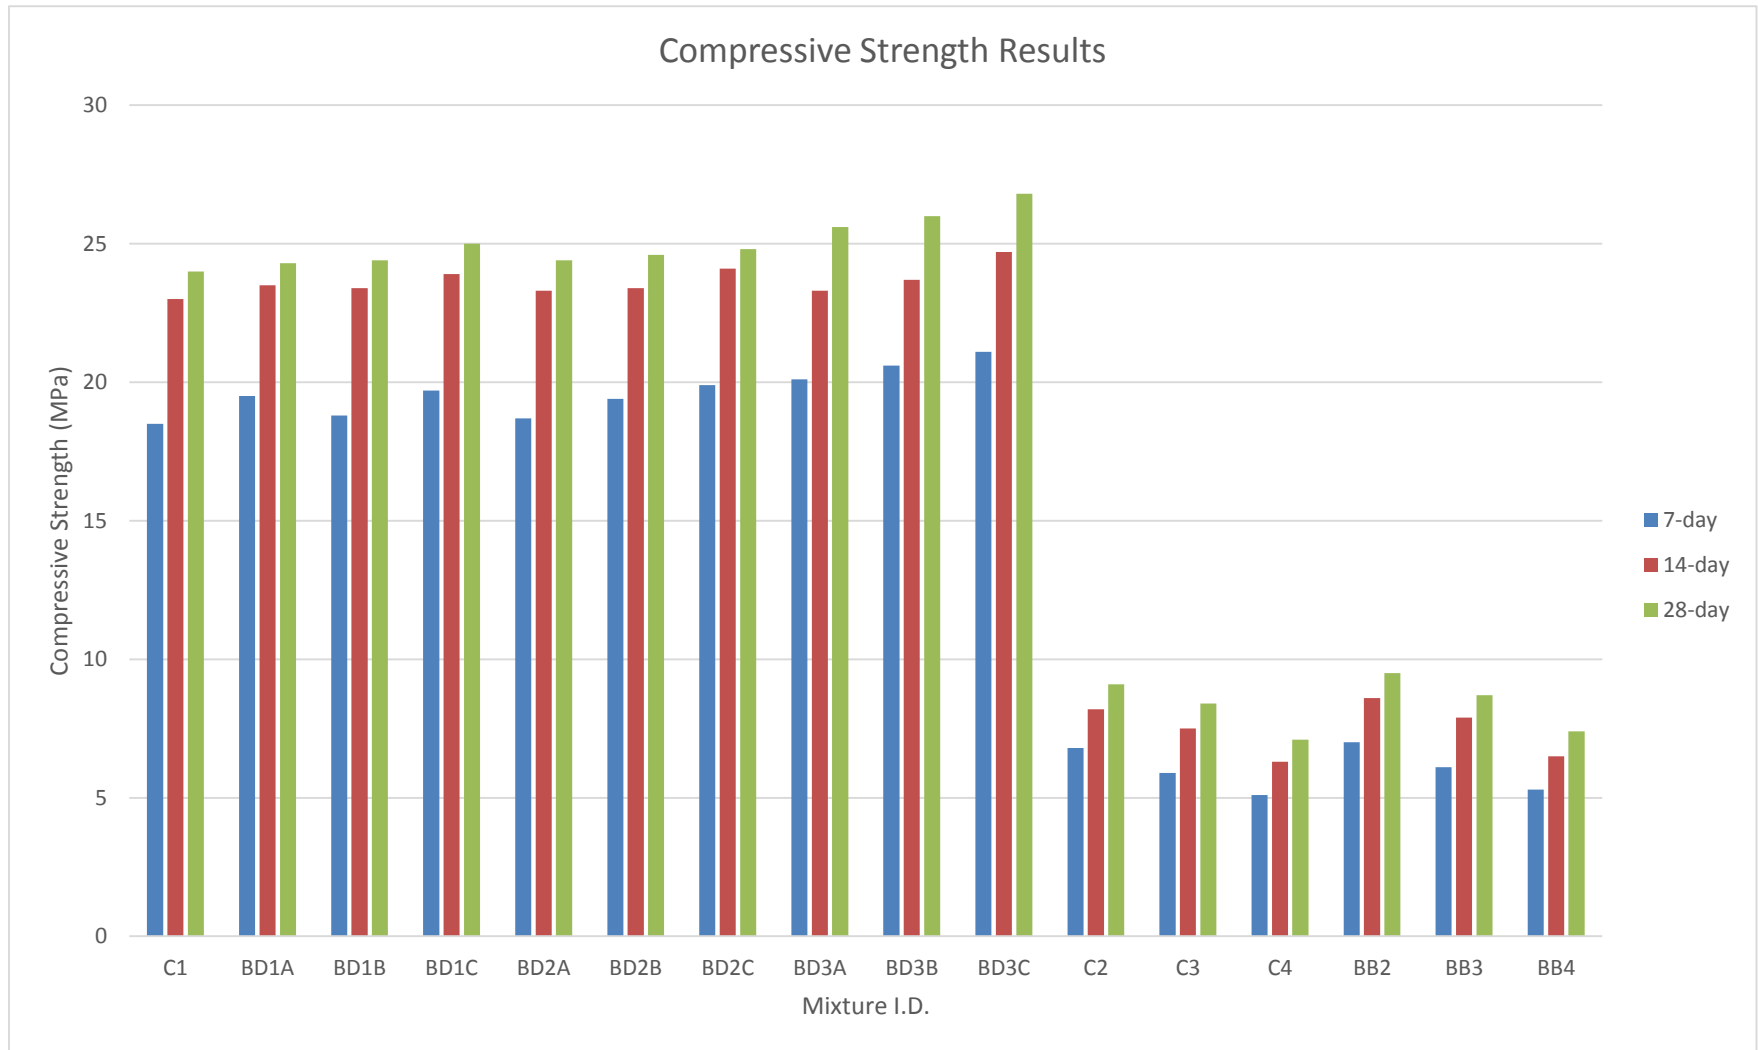
Figure 4-2: Compressive strength results at 7, 14 and 28-days

Mixture	Mixture I.D.	Compressive Strength Results of Cracked Specimen (MPa)		
		7-day	14-day	28-day
Type I	C1	18.5	23.0	24.0
Type II	BD1A	19.5	23.5	24.3
Type III	BD1B	18.8	23.4	24.4
Type IV	BD1C	19.7	23.9	25.0
Type V	BD2A	18.7	23.3	24.4
Type VI	BD2B	19.4	23.4	24.6
Type VII	BD2C	19.9	24.1	24.8
Type VIII	BD3A	20.1	23.3	25.6
Type IX	BD3B	20.6	23.7	26.0
Type X	BD3C	21.1	24.7	26.8
Type XI	C2	6.8	8.2	9.1
Type XII	C3	5.9	7.5	8.4
Type XIII	C4	5.1	6.3	7.1
Type XIV	BB2	7.0	8.6	9.5
Type XV	BB3	6.1	7.9	8.7
Type XVI	BB4	5.3	6.5	7.4

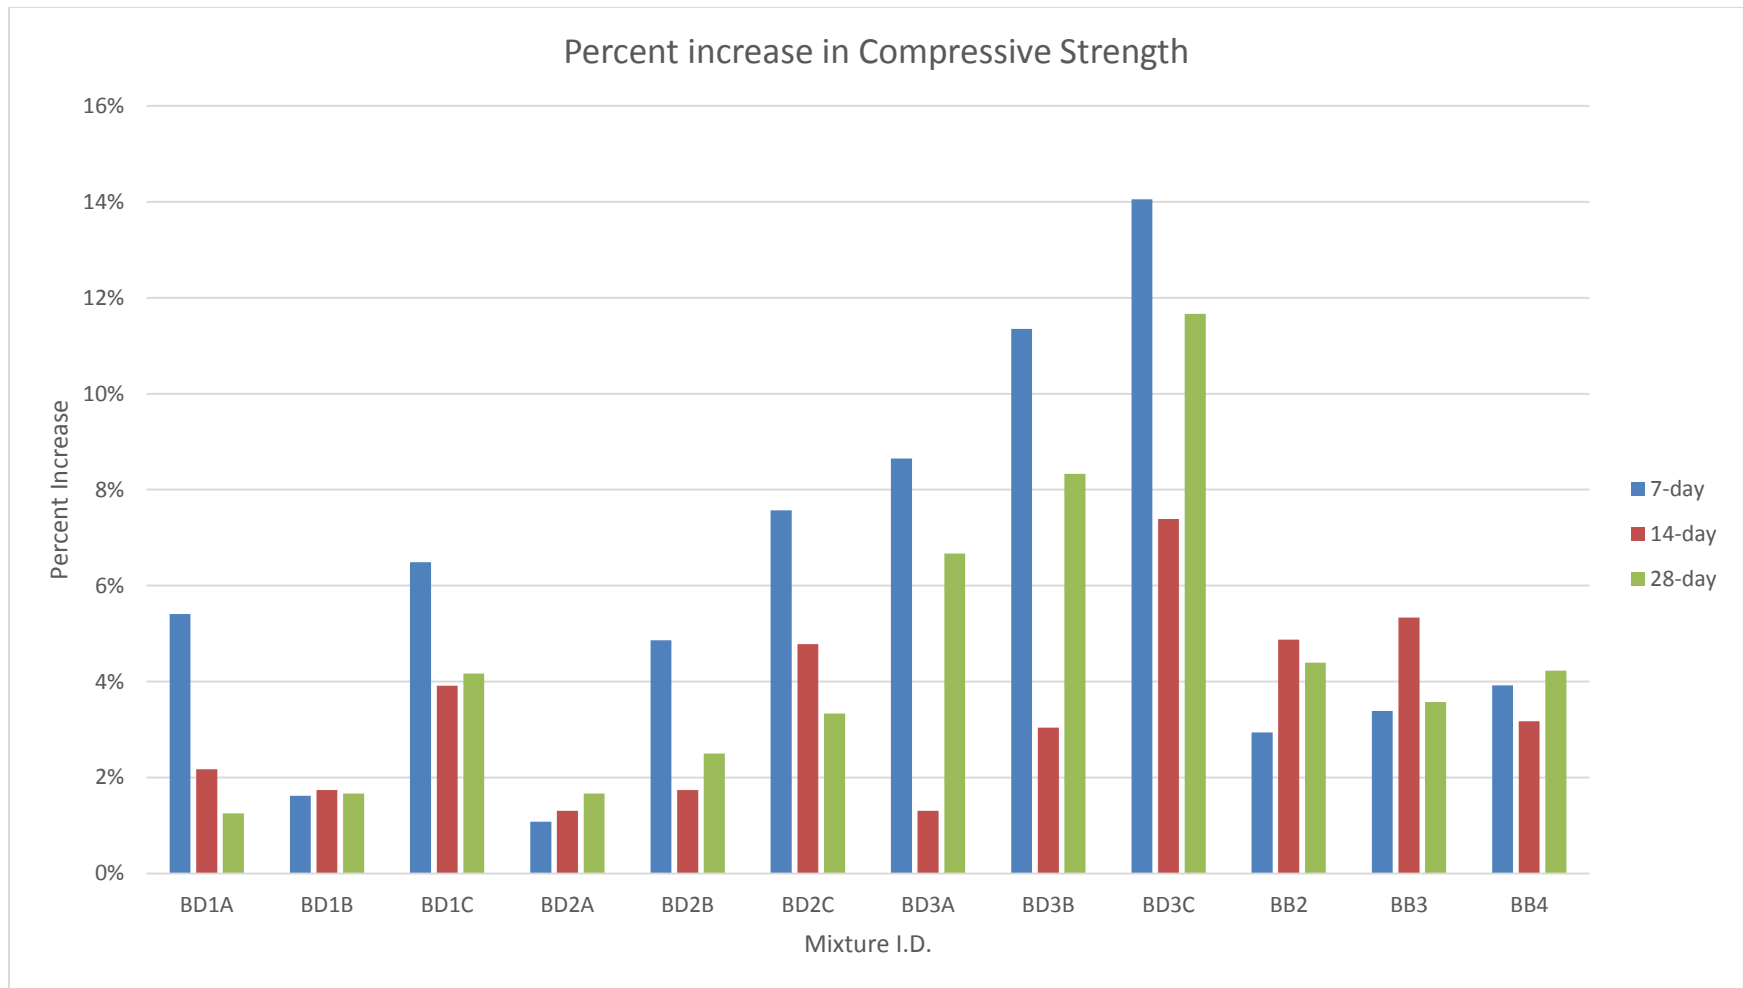
Figure 4-3: Percent increase in compressive strength at the ages of 7, 14 and 28-days

Mixture I.D.	Percent increase in compressive strength		
	7-day	14-day	28-day
BD1A	5%	2%	1%
BD1B	2%	2%	2%
BD1C	6%	4%	4%
BD2A	1%	1%	2%
BD2B	5%	2%	3%
BD2C	8%	5%	3%
BD3A	9%	1%	7%
BD3B	11%	3%	8%
BD3C	14%	7%	12%
BB2	3%	5%	4%
BB3	3%	5%	4%
BB4	4%	3%	4%

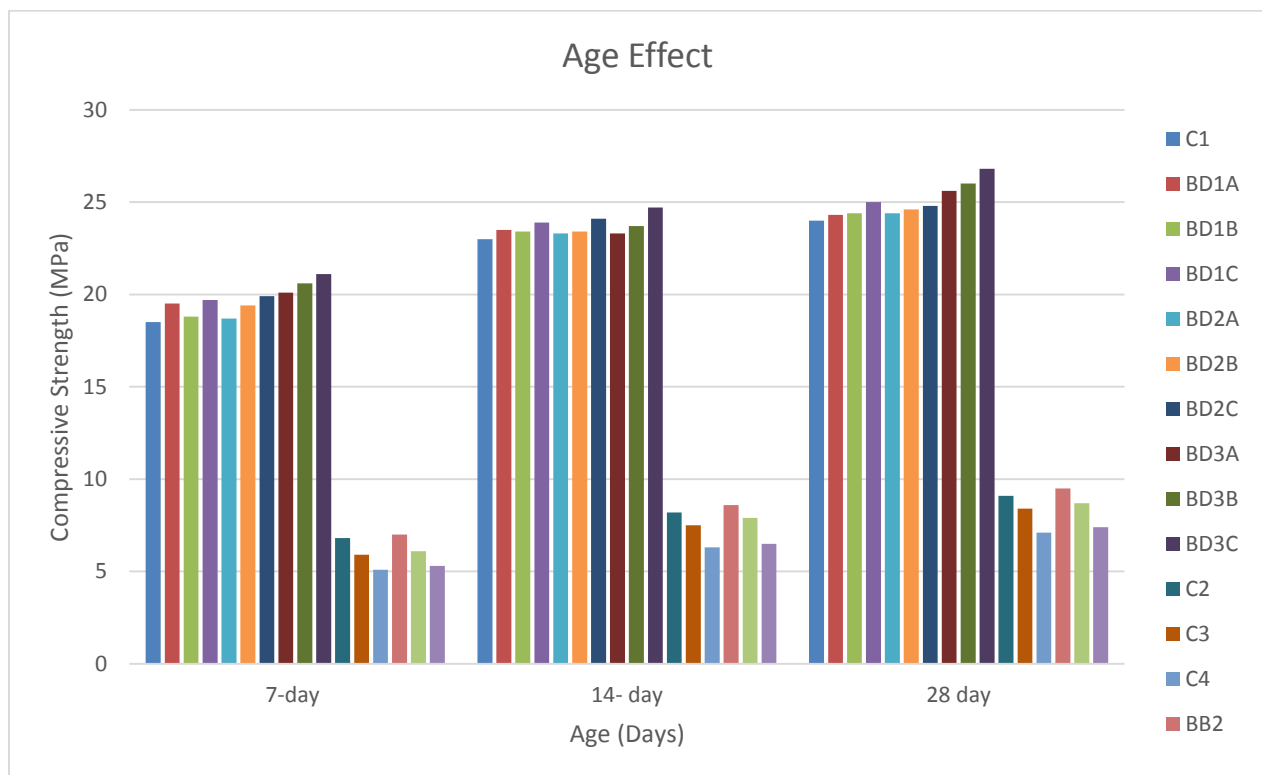
Figure 4-4: Effect of age on compressive strength

It could be concluded from figure 4-4 that the compressive strength constantly increases at the early ages for all the cement mortar mixtures except the ones that use burned Bentonite. It could be also concluded that the mortar mixture BD3C had the highest compressive strength at all ages which confirms that compressive strength increases with both increasing the dosage of bacteria and DE. The increase of compressive strength with time is likely due to the original properties and chemical reactions of cement in mortar. On the other hand the specimens containing burned Bentonite exhibit the same trend which could be also explained as due to the property of cement hardening with time as well however, with lower variations.
